**RE: 1446 NW 53<sup>rd</sup> St Mixed Use – Project Completion**  
**DPD Project No: 66391152**

## Field Report

## STRUCTURAL WOOD FRAMING INSPECTION REPORT

Project Name: 53rd Apartments (Chinook Ballard)

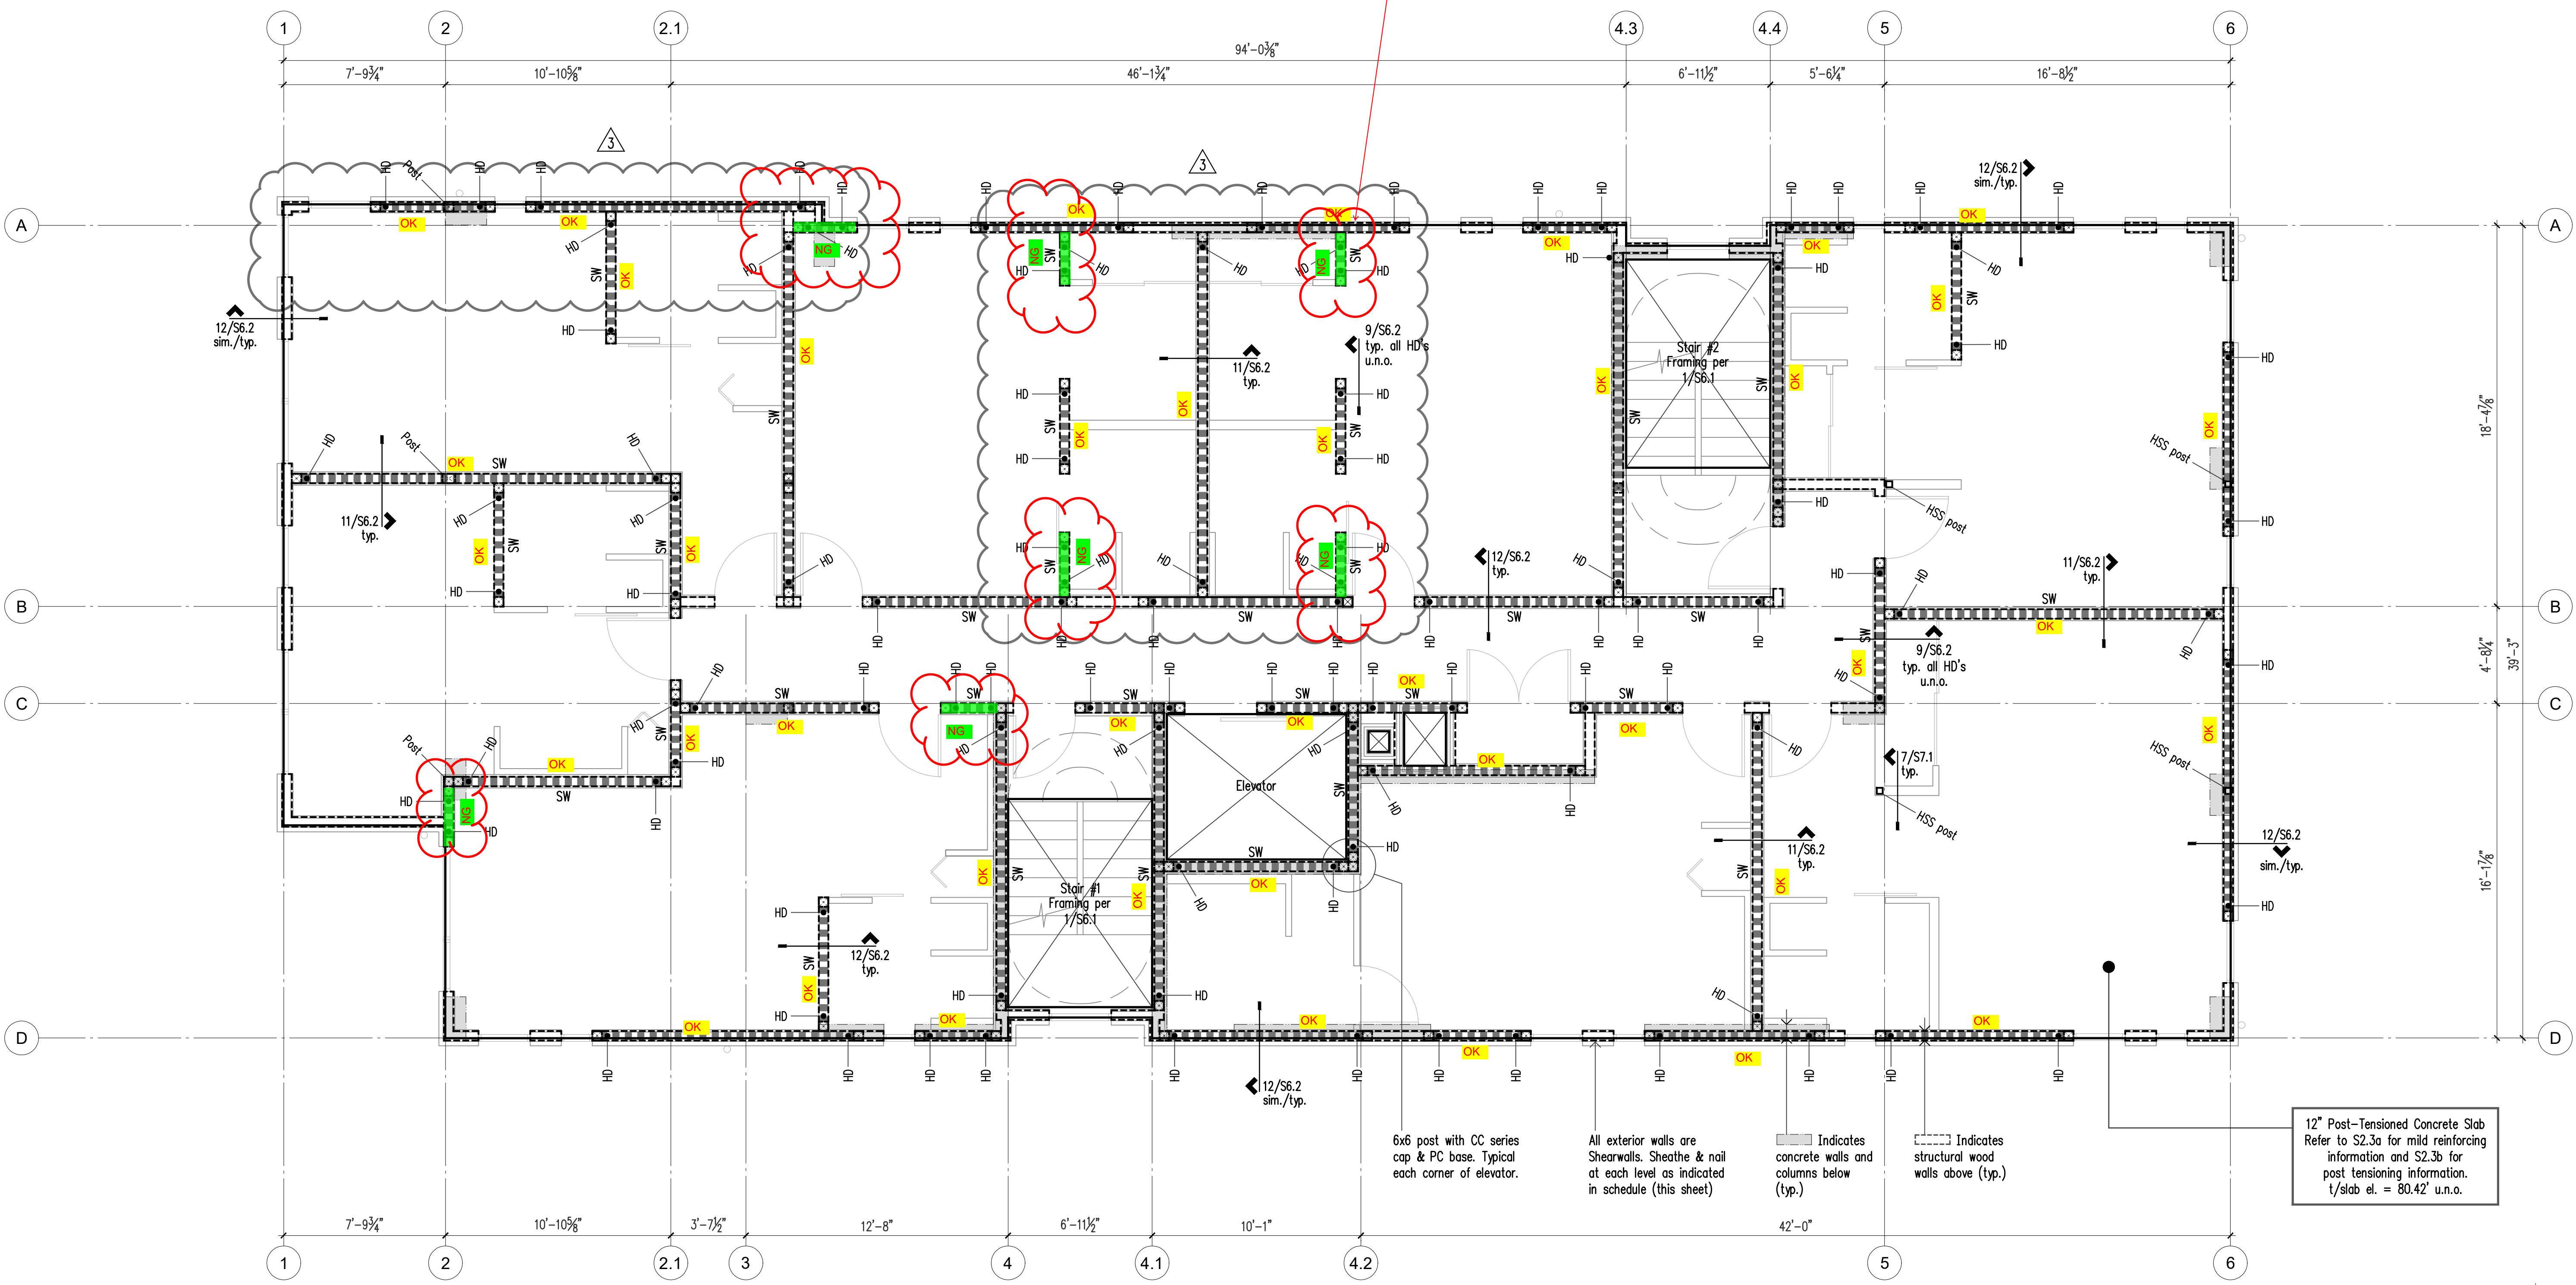
SSK-13: Shear wall anchor bolt washer requirements  
EAF/Frank Co.  
02-16-2023

18. The condition was evaluated at the PT slab level, and the criteria for meeting the exception to the requirement for the plate washer within 1/2" of sheathed edge of the walls are met in all but the

locations provided in SSK-13 attached. Plate washers within 1/2" of sheathed edge are required at the locations noted in SSK-13.

CLOUDED LOCATIONS HILIGHTED  
IN GREEN ARE REQUIRED TO HAVE  
PLATE WASHERS WITHIN 1/2" OF  
THE EDGE OF THE BOTTOM PLATE  
ON SHEATHING SIDE OF THE WALL.
