Arborist Report

Arborist Report DRAFT

TO: Judd Eddy – B+H Architects
SITE: 1522 5th Ave, Seattle, WA 98101
RE: Tree Inventory and Assessment
DATE: September 25, 2019
PROJECT ARBORIST: Tyler Bunton
ISA Certified Arborist #PN-8715A, ISA Qualified Tree Risk Assessor
Josh Petter
ISA Certified Arborist #PN- 8406A, ISA Qualified Tree Risk Assessor
ATTACHED: Table of Trees, Tree Site Map
REFERENCED DOCS: 30% Street Improvement Plan (dated 6/18/2019)

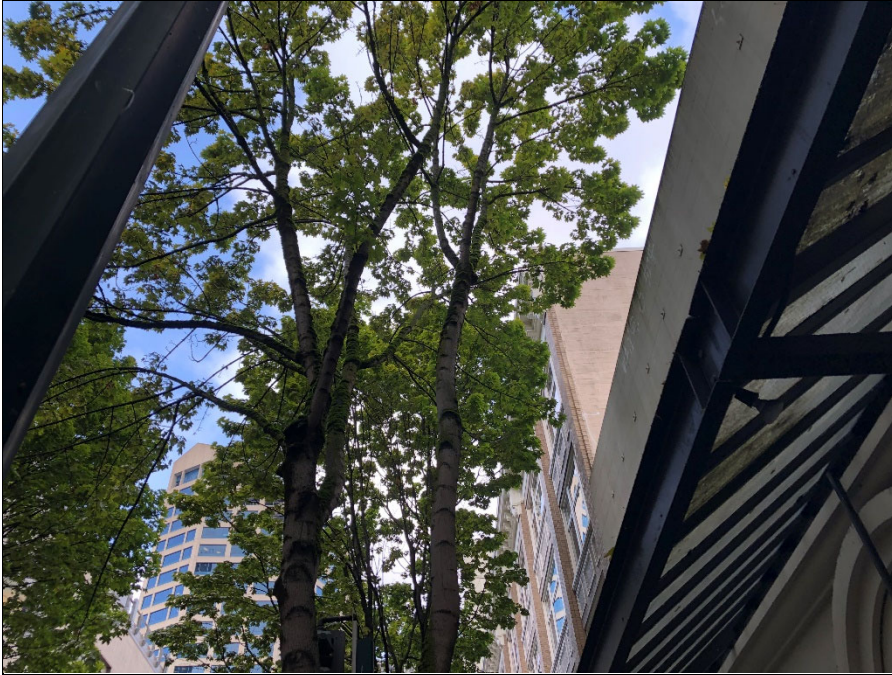
Photo 1. Tree 96318 with lion-tailed branches that have little taper.

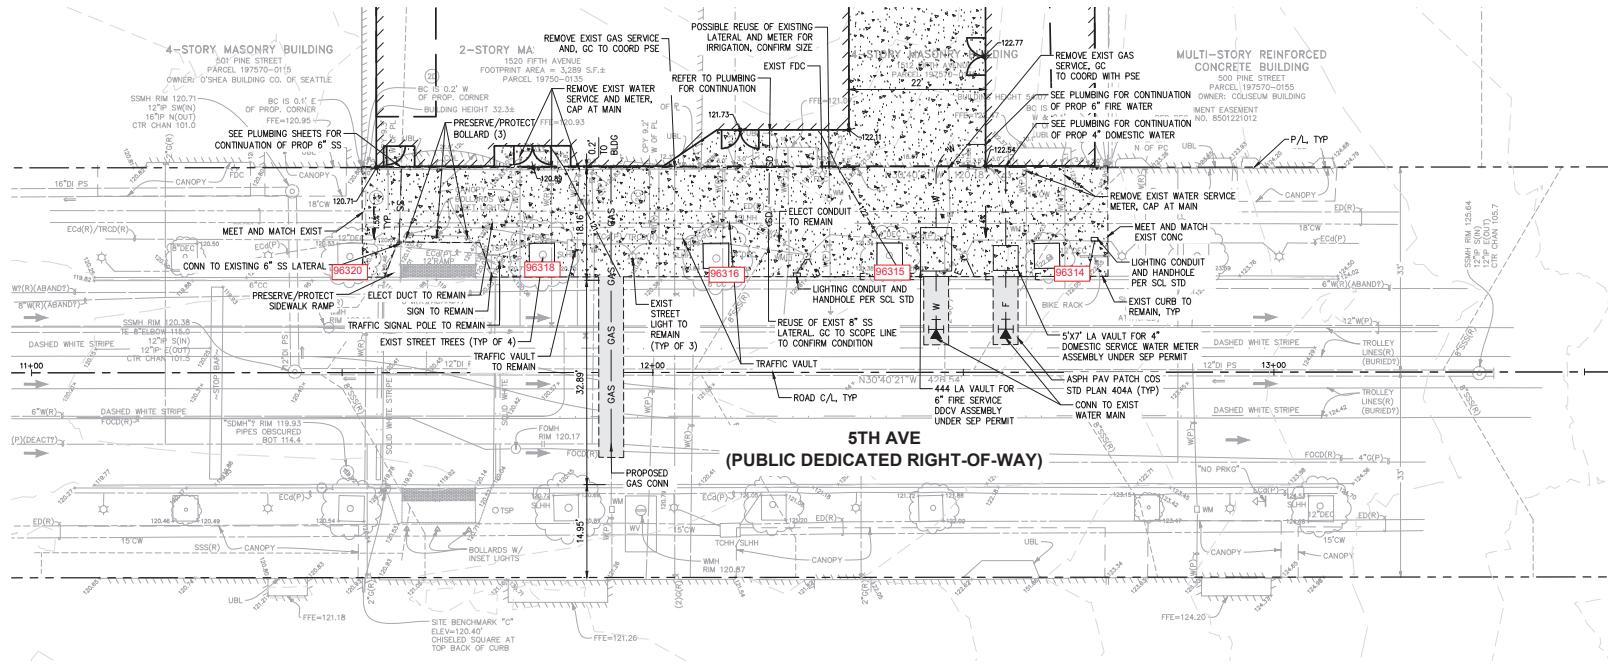
Tree Inventory
September 25, 2019

According to the 30 percent SIP new water service and gas lines are proposed within the critical root zones, defined by SDOT as one half of the dripline, of trees 96314, 96315, and 96318. Excavation for these lines within critical root zones must be done by pneumatic air excavation to a depth of 3 feet cutting no roots greater than 2 inches in diameter. If excavation must occur deeper than 3 feet a hydrovac truck may be used for the remainder of excavation. All exposed roots must be wrapped in burlap prior to hydrovac excavation to protect them from any accidental damage from being sprayed with high pressure water. The gas and water lines must be placed below roots without damaging them, unless root cuts are necessary to place the lines in the trench.

Tree inventory took place on September 18, 2019 and included all street trees within the right of way which may be impacted by development. Dripline measurements and other tree specifics are listed in the tree table produced by Tree Solutions Inc. and should be added to this drawing prior to any design relating to tree protection.

Excavation for the installation of the water utility vaults must be done by pneumatic air excavation to a depth of 3 feet at the edge of excavation to cut roots cleanly.

Existing sidewalk pavement must be left in place as long as possible to protect existing soils from further compaction, and prevent damage to tree roots below the pavement.
