# Greenforest Incorporated

REFERENCE: Regulated Tree Inventory

SITE ADDRESS: 6817 Greenwood Ave N, Seattle WA

DATE: May 11, 2022

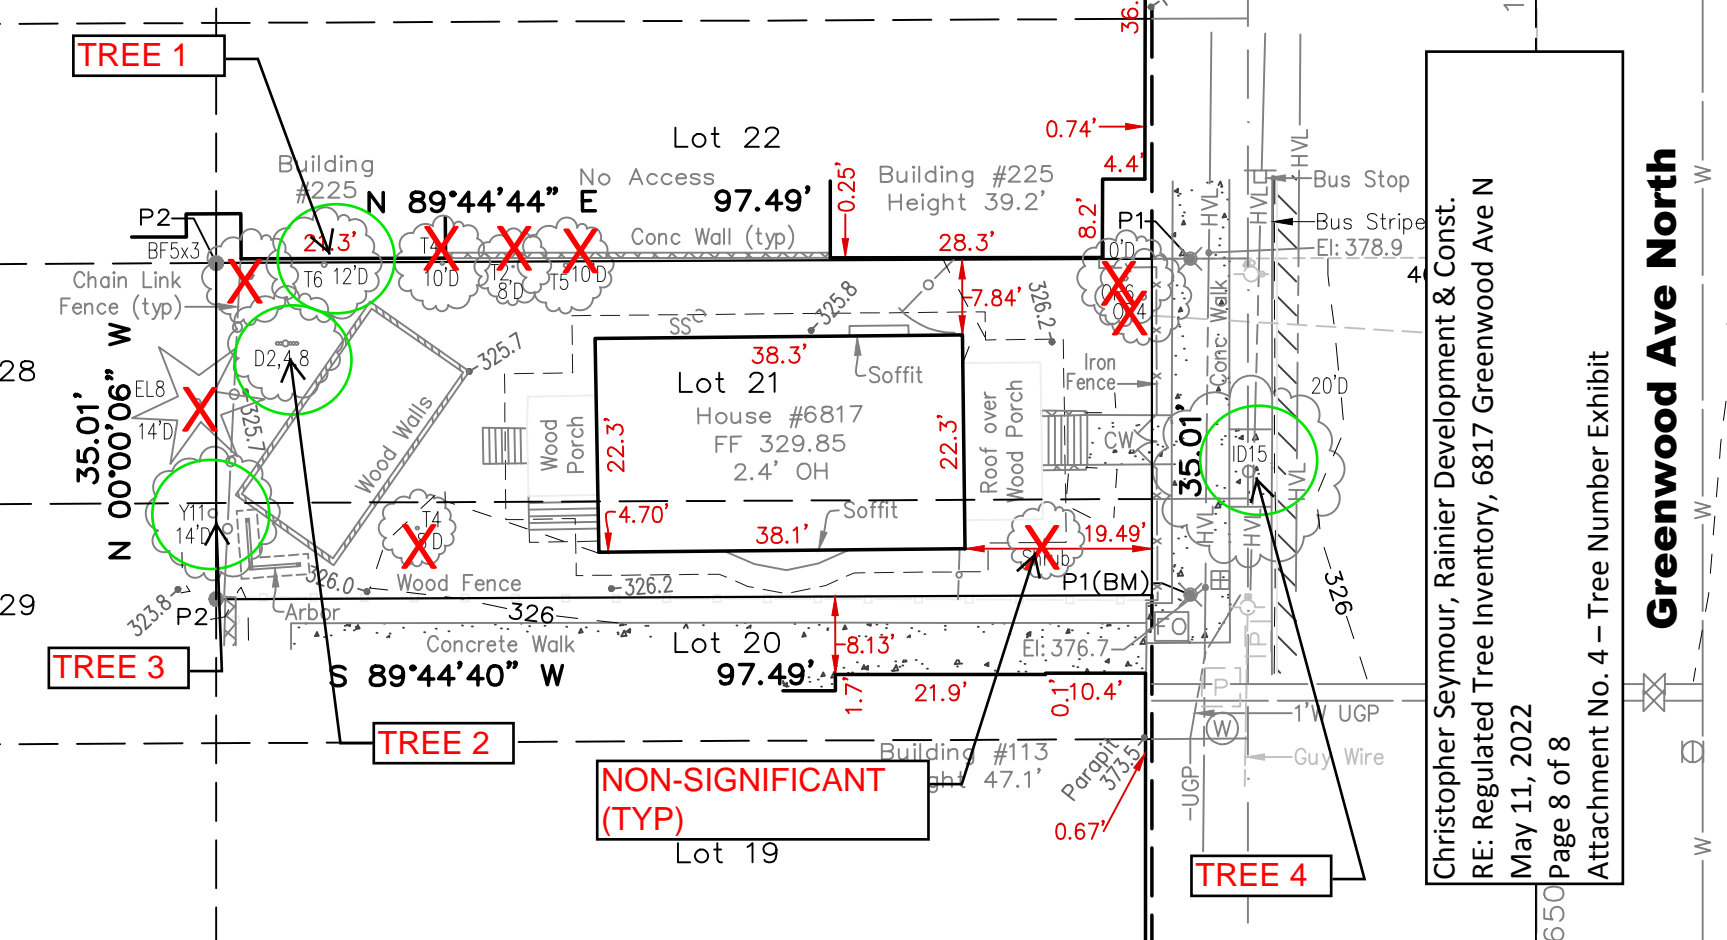
## Attachment No. 4 – Tree Number Exhibit

Three significant trees stand at the west end of the subject parcel: two fruiting trees, and an evergreen yew.

At the east end of the parcel is a street tree growing in the right-of-way.
