## ARBORIST REPORT

9057-9059 16<sup>th</sup> Avenue SW  
Seattle, WA

May 6, 2022

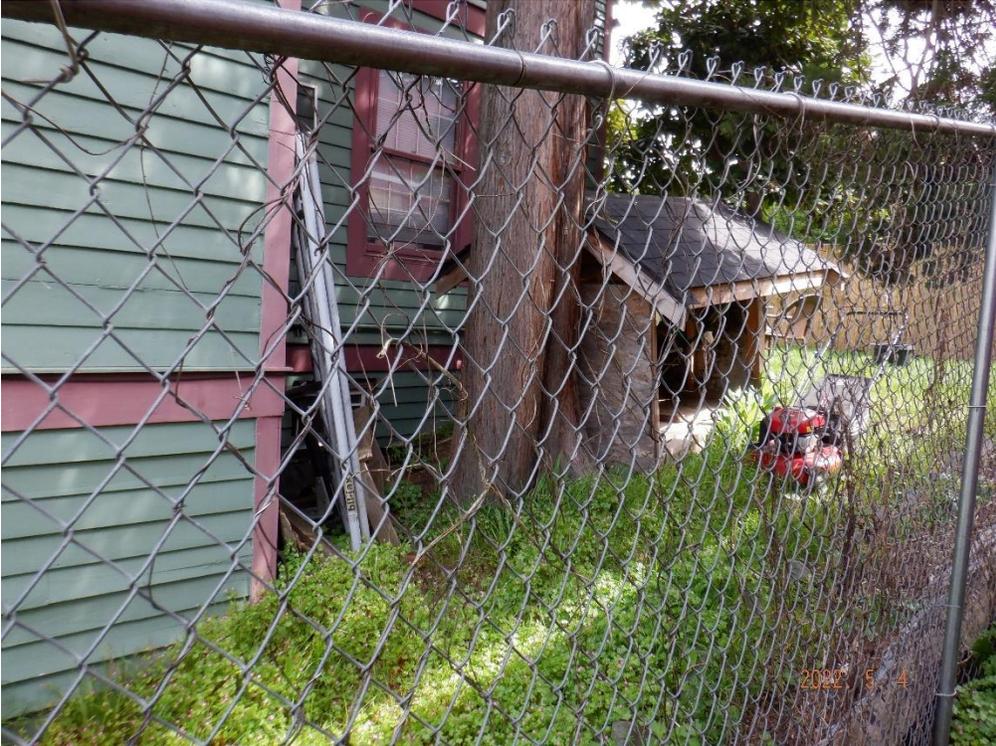
Tree #1 – lower trunk

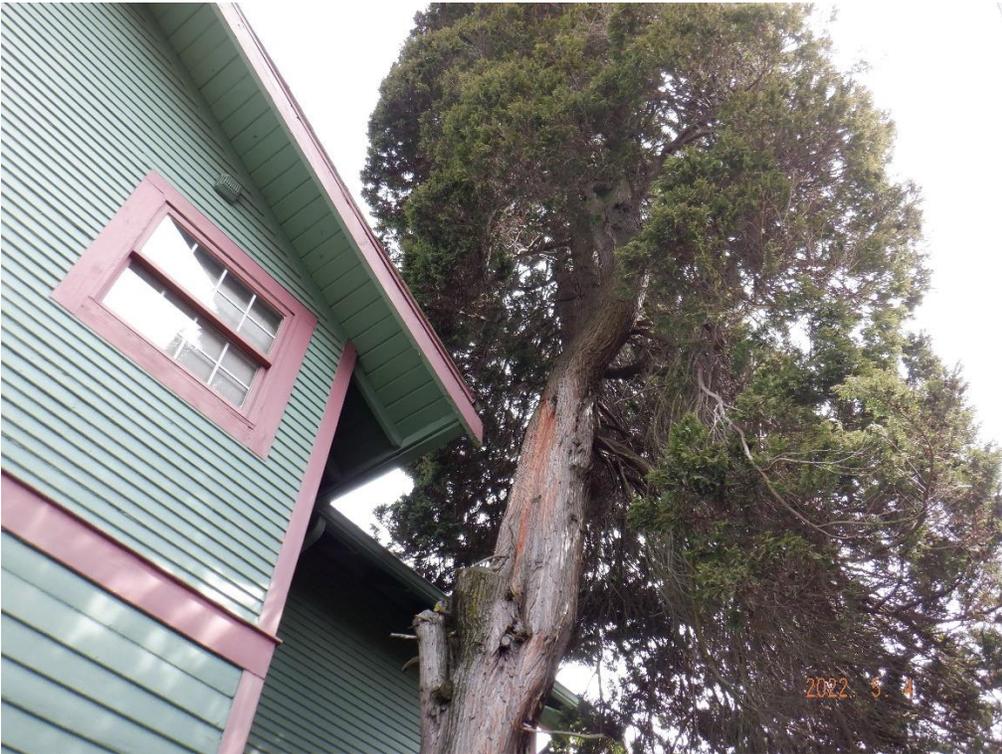
Tree #1 – upper stem/crown

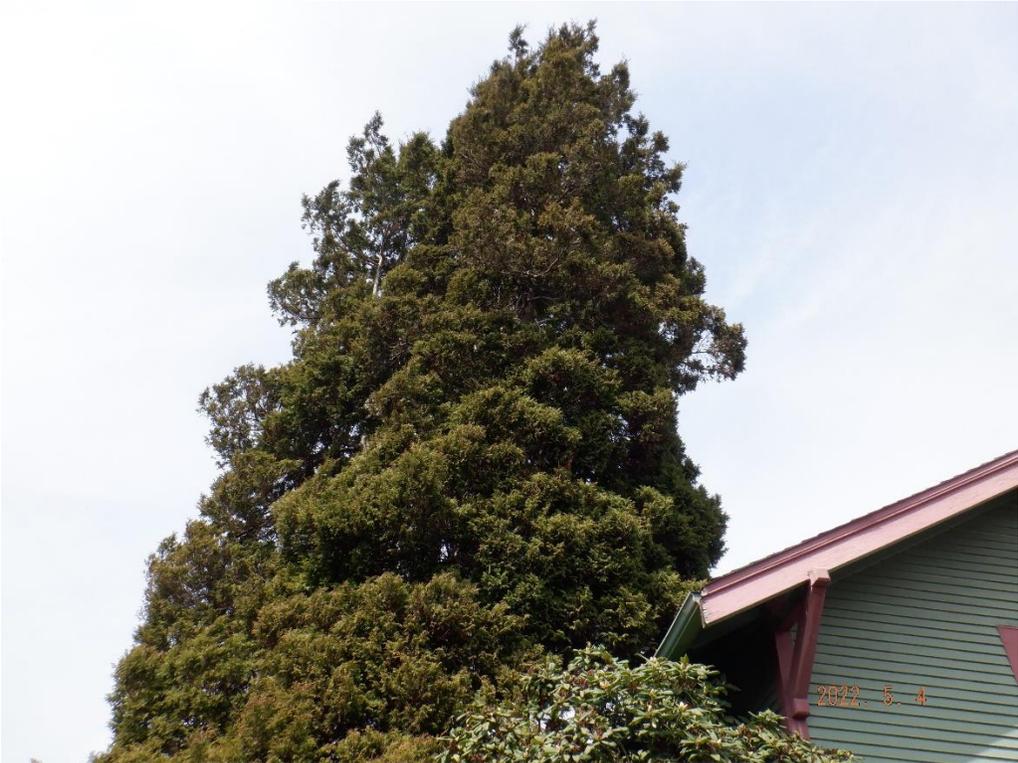
Tree #1 – upper crown

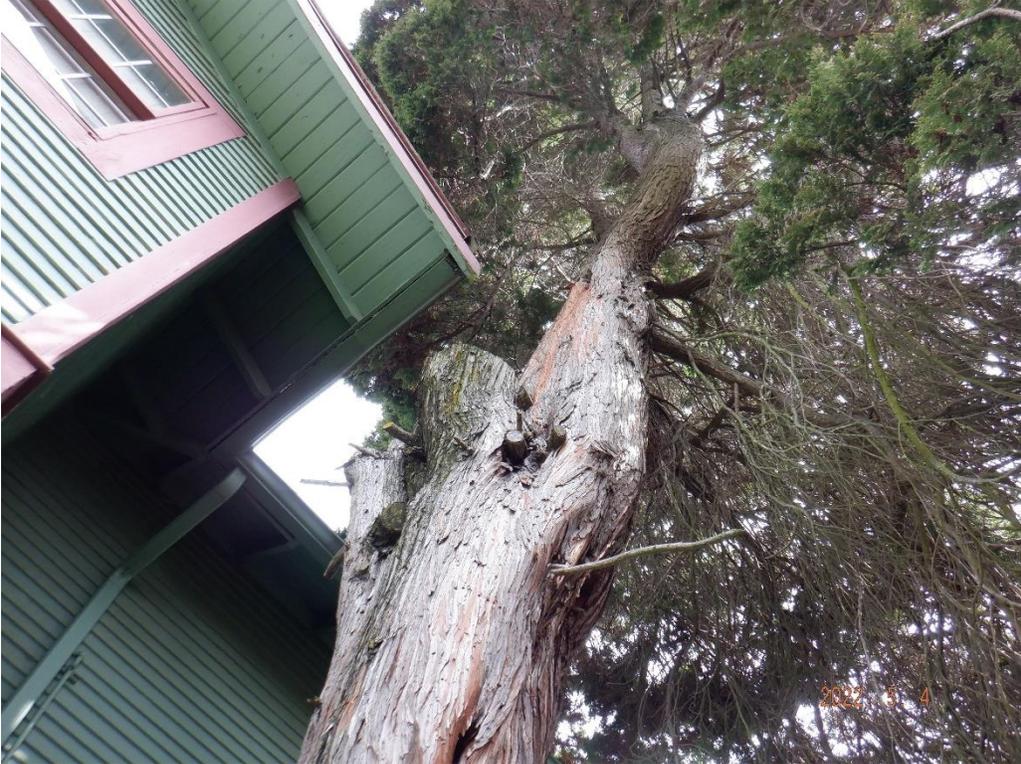
Tree #1 is believed to be a semi-mature Lawson cypress, also called Port Orford cedar or false cypress. A common species found in the region with many cultivated varieties. It has one main trunk that forks into multiple tops, typical development of the species. Some forked stems have been removed in the past for house clearance. It is located within a very close proximity of the existing house. See pictures below. Vigor is good. Foliage is of normal color and density. Condition is 'fair'.

Tree #1 – stems cut back for house clearance

Given the proximity of the existing old structures both on the north and south sides of Tree #1, it will be extremely difficult to preserve it in a viable condition. The feeder roots can be expected to be found several of feet beyond the dripline. Since it is larger than 24-inches in diameter, it will require replacement if removed.
